An Evaluation of Different Material Line Insulators under High Voltage AC and Bipolar DC Excitation in a Marine Polluted Environment

by
Gerton Nicolaas Jacobus Mouton

*Thesis presented in partial fulfilment of the requirements for the degree
Master of Science in Engineering at Stellenbosch University*

December 2012

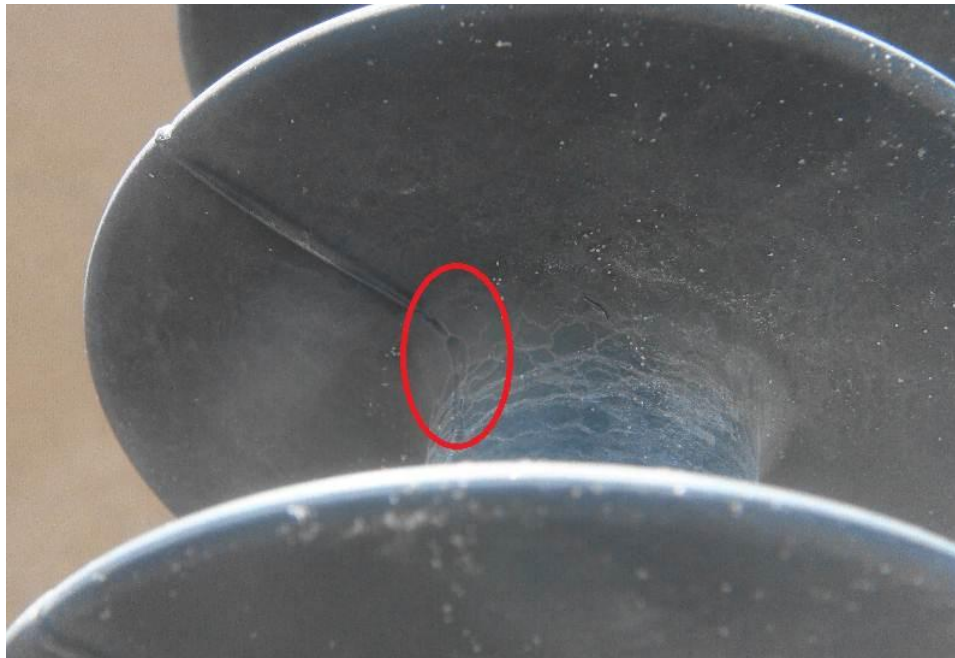
It is evident from Table 5-7 that light erosion observations were more prominent on the mould lines, the east side of the insulator and close to the earthed side of the insulator. Furthermore, it is noted that all of the light erosion observations were preceded by light pollution and dry band formations. The dry band formations are indicative that there were electrical discharge activities at the respective areas and it could be the cause of material erosion. Please refer to Figure 5-10 and Figure 5-11 for photographs of light erosion observations on AC_EPDM insulator.

Figure 5-10: Light erosion observation on the mould line of the sheath and shed bottom of the AC_EPDM insulator

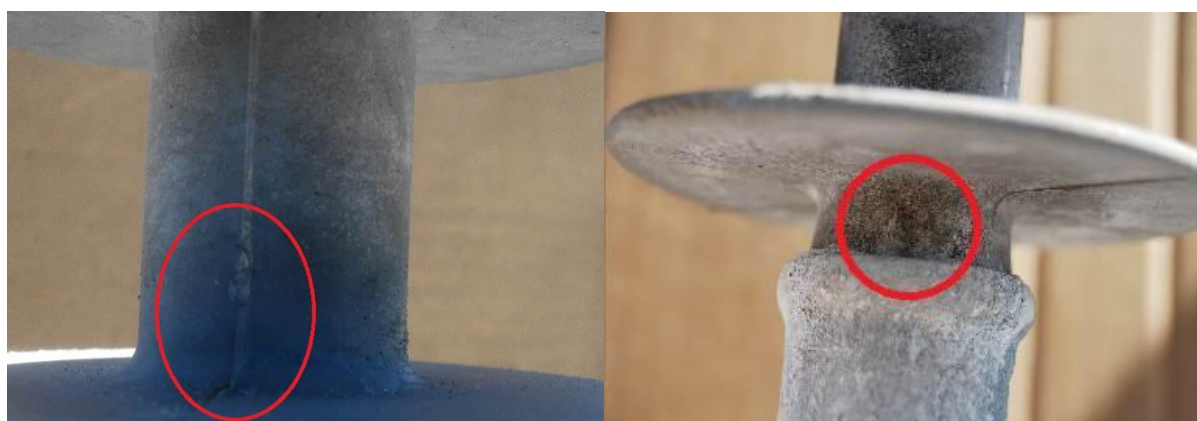
It is evident from Table 5-8 that the light erosion observed is located more prominently, on the sheath section of the insulator. However, no conclusions can be made regarding the prominent direction and axial position of the light erosion observations on the insulator. Furthermore, it is noted that all of the light erosion observations were preceded by light pollution, dry band formations and crazing within the pollution layer. The dry band formations are indicative that there were electrical discharge activities at the respective areas and this could be the cause of material erosion. Please refer to Figure 5-12 for photographs of light erosion observations on AC_HTV insulator.

Figure 5-12: Light erosion observations on the AC_HTV insulator

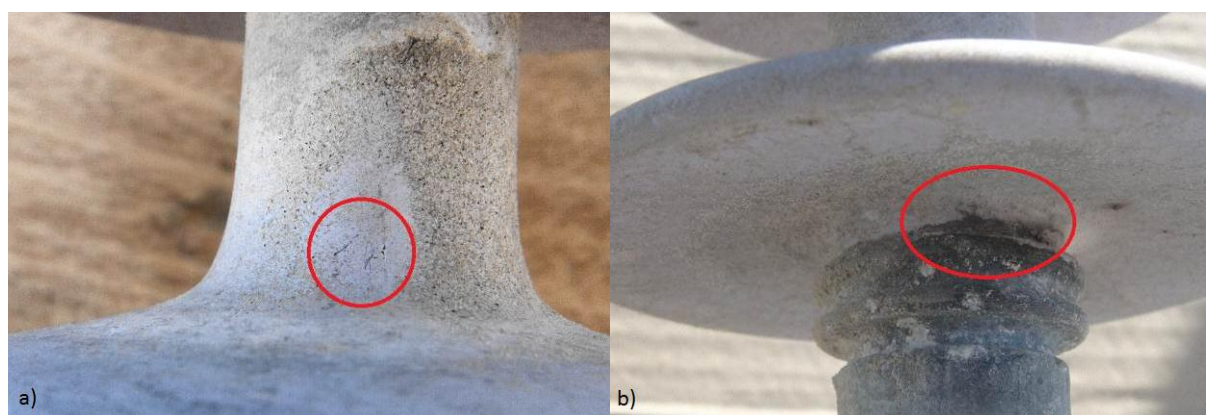
No conclusions can be made regarding the prominent direction, axial position and insulator position of light erosion and erosion observations on the insulator. Furthermore, it is noted that the light erosion and erosion observations were preceded by dry band formation and crazing within the pollution layer activities. The erosion observation was on the 1st shed bottom and it was preceded, in addition, by colour change activities, which are also a sign of material degradation. The dry band and colour change observations are indicative that there were electrical discharge activities at the respective areas and this could be the cause of material erosion. Please refer to Figure 5-13 for photographs of light erosion and erosion observations on the AC_RTV insulator.

Figure 5-13: Light erosion (a) and erosion (b) observations on the AC_RTV insulator

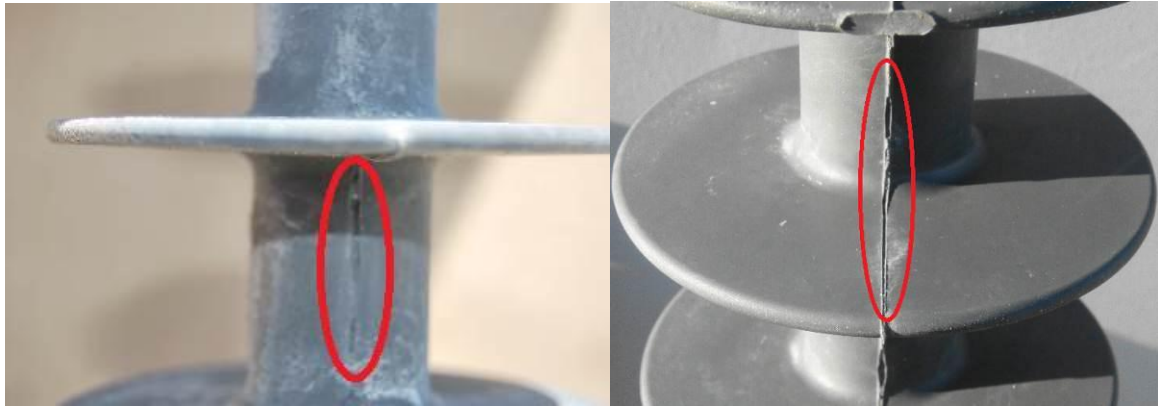
Mould line of 6th sheath	West	Light pollution, dry band
	Mould line of 4th shed bottom	West	Light pollution, dry band, salt crystals

Figure 5-14: Light erosion observations on mould line of the DC+_EPDM insulator

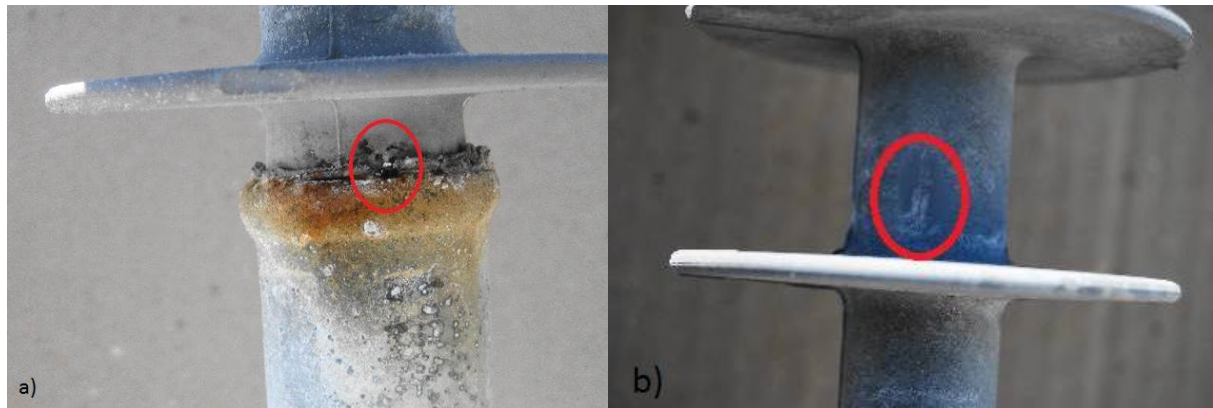
pollution and dry band formations. The dry band observations are indicative that there were electrical discharge activities at the respective areas and this could be the cause of material erosion. Please refer to Figure 5-18 for photographs of light erosion and erosion observations on the DC+_HTV insulator.

Figure 5-18: Observations of erosion on sealant (a) and light erosion on sheath (b) of the DC+_HTV insulator

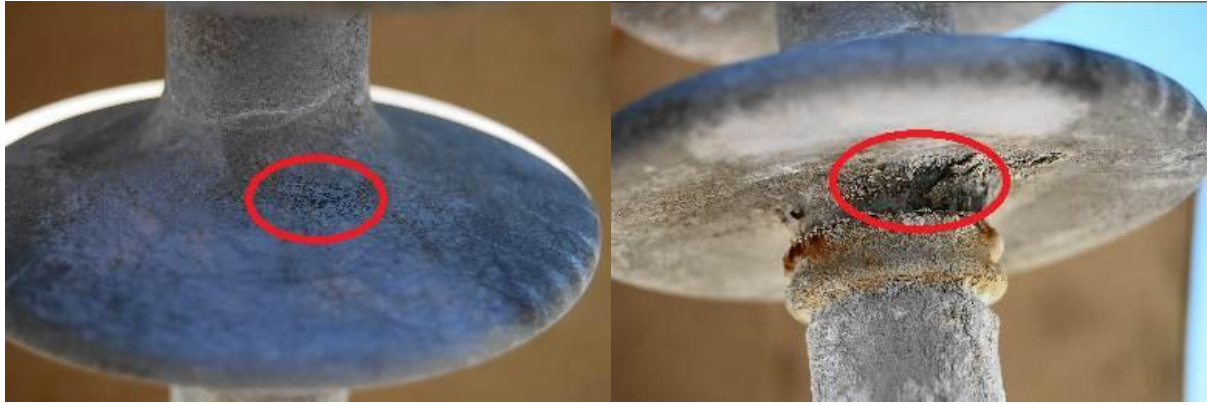
5th shed top	South	Medium pollution, dry band, colour change, crazing within pollution layer
	6th shed top	South	Medium pollution, dry band, colour change, crazing within pollution layer, rust spots, salt crystals
	6th shed bottom	South	Medium pollution, dry band, colour change, crazing within pollution layer, salt crystals
2012/02/08 (Day 371)	5th sheath	East	Medium pollution, dry band, colour change, crazing within pollution layer
	2nd shed top	South	Medium pollution, dry band, colour change, crazing within pollution layer

Figure 5-19: Erosion observations on shed top and shed bottom of the DC+_RTV insulator

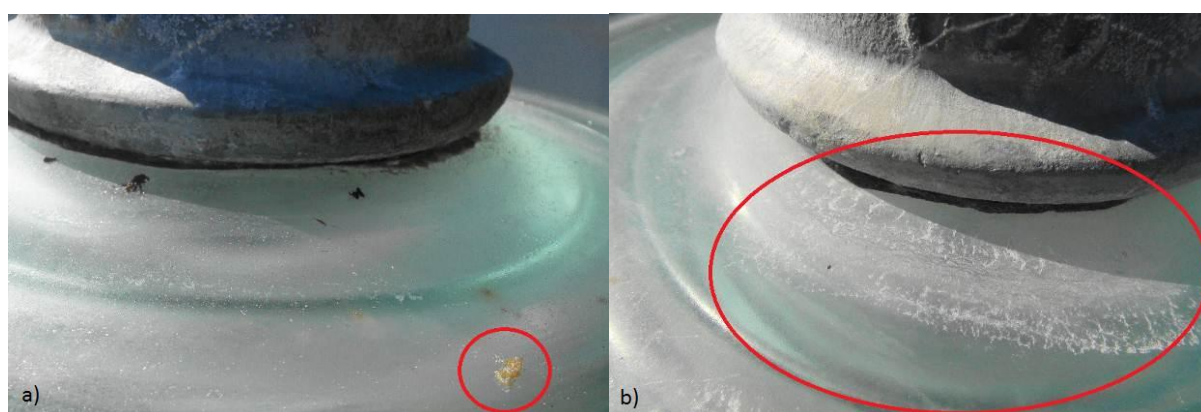
**Figure 5-21: Grease stain (a) and glass erosion observations on shed top (b) of the DC+_Glass insulator**

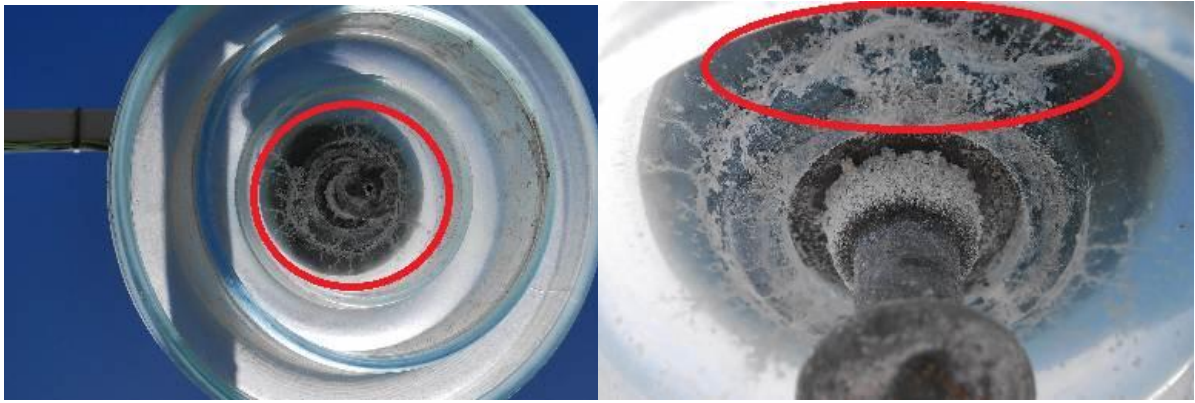
It is evident from Table 5-13 and Figure 5-22 that glass erosion observations were more prominent around the pin area on the bottom side of the insulator. As seen in Figure 5-22, there is no cement growth or swelling of the pin, which could have put a mechanical force on the glass disc leading to the formation of glass erosion. Thus, it may be assumed that the glass erosion was caused by electrical discharge activity, as indicated by the dry band formations on the glass disc preceding the glass erosion. It is also noted in Table 5-13 that the glass erosion observation on the top side of the glass insulator was preceded with a grease stain. This grease stain could have possibly come from the grease applied at the earth wire connection point on the cap, which preserves the connection point from corrosion. Please refer to Figure 5-21 and Figure 5-22 for photographs of glass erosion observations on the DC+_Glass insulator.

Figure 5-22: Glass erosion observations on the shed bottom of the DC+_Glass insulator

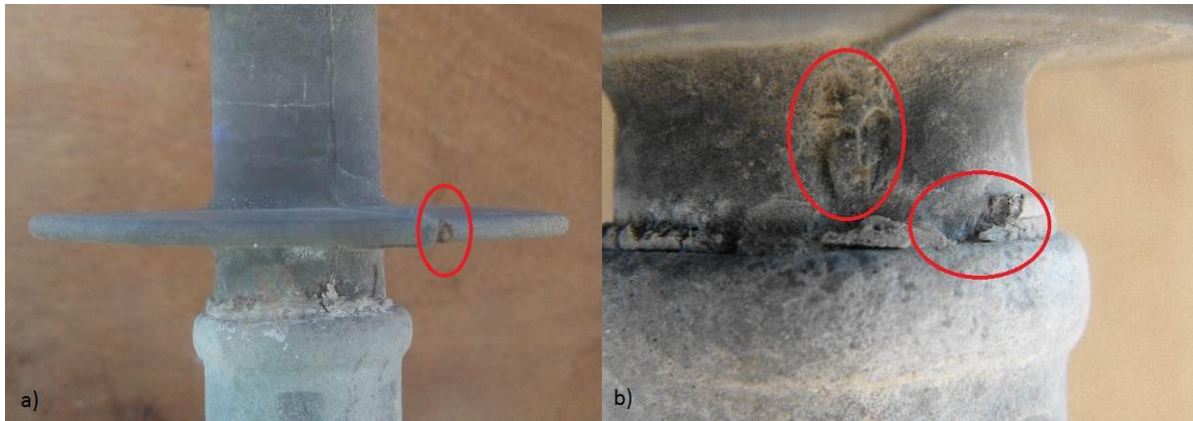
All the observations regarding the sealant as summarized in Table 5-14 are erosion observations. Furthermore, it is noted that the light erosion observations were more prominent on the mould line, the west and east side of the insulator and close to the live end fitting of the insulator. It is also noted that most of the light erosion and erosion observations were preceded by light pollution and dry band observations. The dry band formations are indicative that there were electrical discharge activities at the respective areas and this could be the cause of material erosion. Please refer to Figure 5-23 and Figure 5-24 for photographs of light erosion and erosion observations on the DC-_EPDM insulator.

Figure 5-23: Observations of light erosion on shed rim (a) and erosion on sealant as well as light erosion on sheath (b) of the DC-EPDM insulator

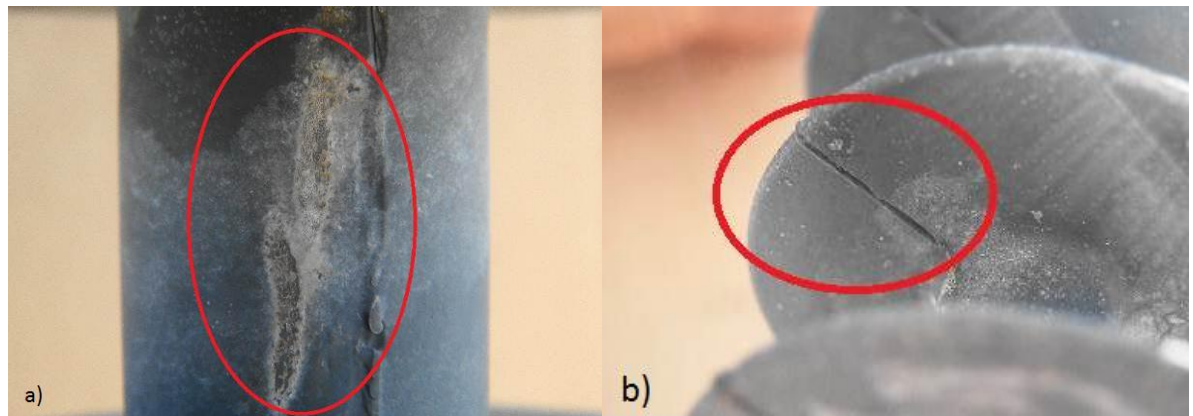
Figure 5-24: Observations of light erosion on sheath (a) and light erosion on mould line of shed bottom (b) of the DC-EPDM insulator

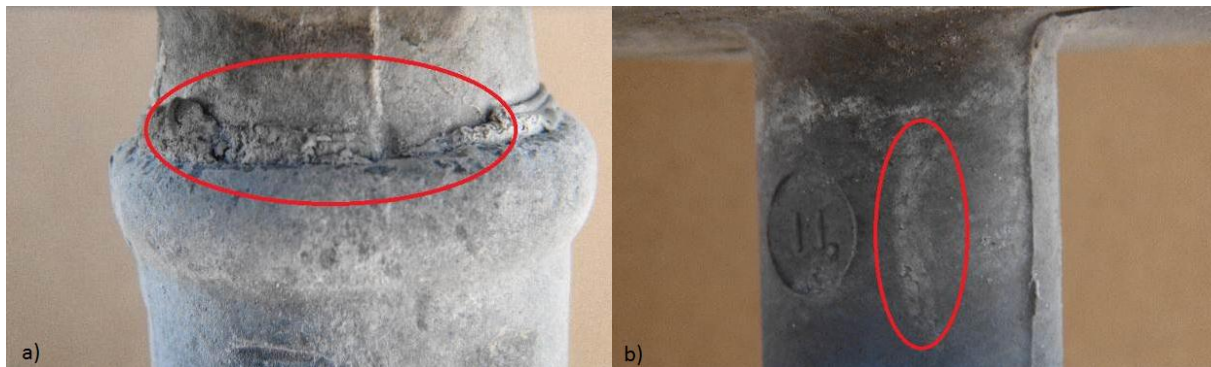
From the above table it is noted that the light erosion observations are more prominent on the sheath sections, the south side of the insulator and close to the live end fitting of the insulator. It is also noted that most of the light erosion and erosion observations were preceded by light pollution and dry band formation observations. The dry band formations are indicative that there were electrical discharge activities at the respective areas and this could be the cause of material erosion. Please refer to Figure 5-25 and Figure 5-26 for photographs of light erosion and erosion observations on DC-_HTV insulator.

Figure 5-25: Observations of erosion on sealant (a) and light erosion on sheath (b) on the DC-HTV insulator

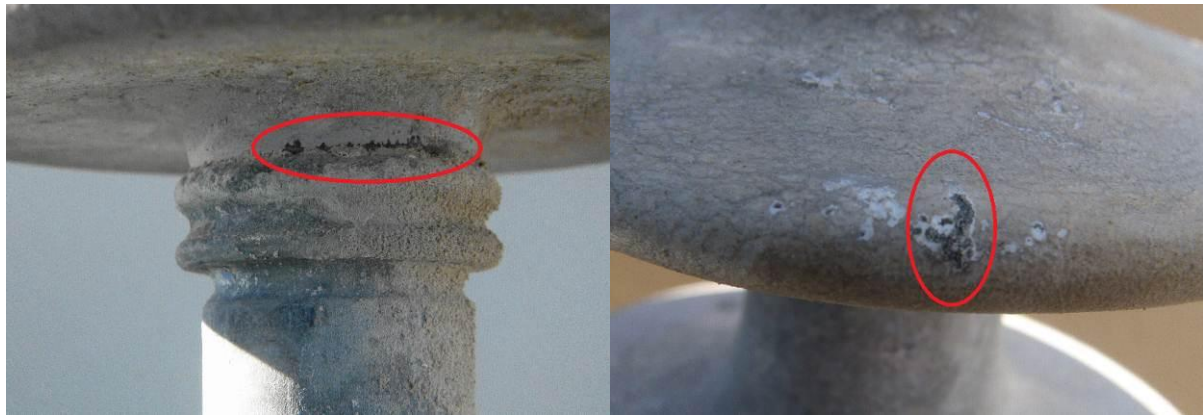
From the observations listed in Table 5-16, the observation on shed 1 bottom, which was observed on 19 May 2011, and the observation on shed top 3, which was observed on 1 December 2011, are erosion observations. The other observations are light erosion observations, which are more prominent on the sheath sections of the insulator. Furthermore, the light erosion and erosion observations are more prominent on the south side of the insulator and close to the live end fitting of the insulator. It is also noted that most of the light erosion and erosion observations were preceded by light pollution, dry band formation, crazing within the pollution layer and colour change observations. A colour change activity in itself is also a sign of material degradation. The dry band and colour change observations are indicative that there were electrical discharge activities at the respective areas and this could be the cause of material erosion. Please refer to Figure 5-27 and Figure 5-28 for photographs of light erosion and erosion observations on the DC-_RTV insulator.

Figure 5-27: Erosion observations on the DC-_RTV insulator

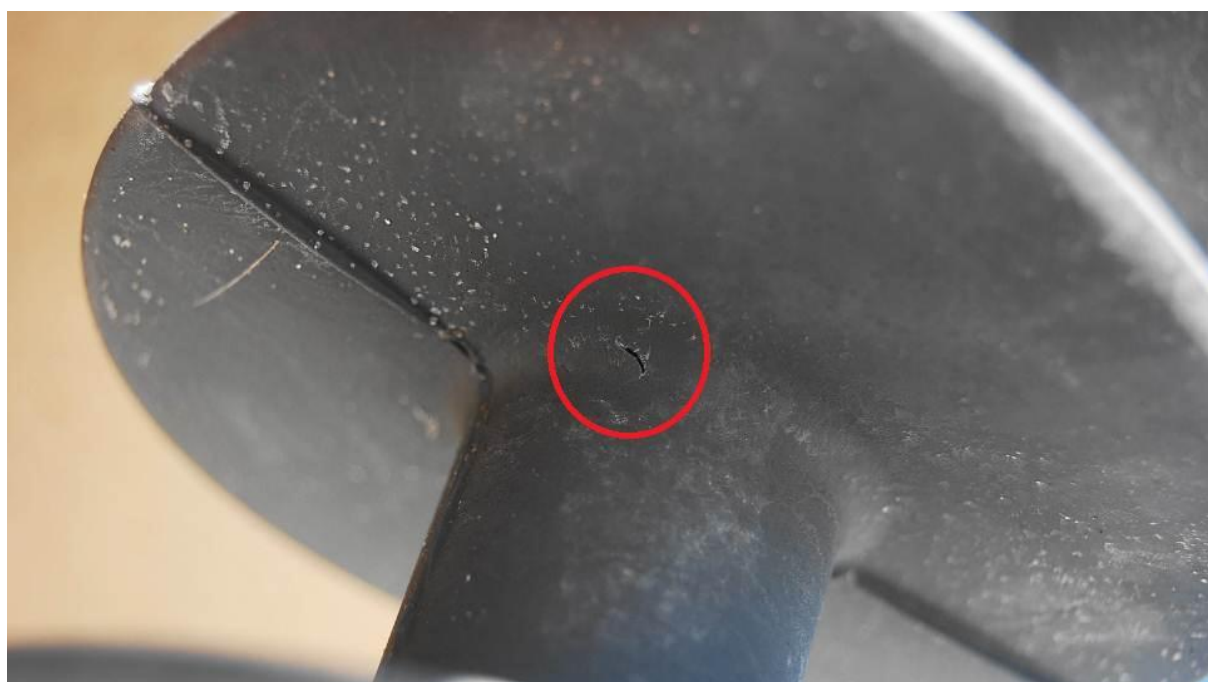
Figure 5-31: Minor split or cut on AC_EPDM insulator

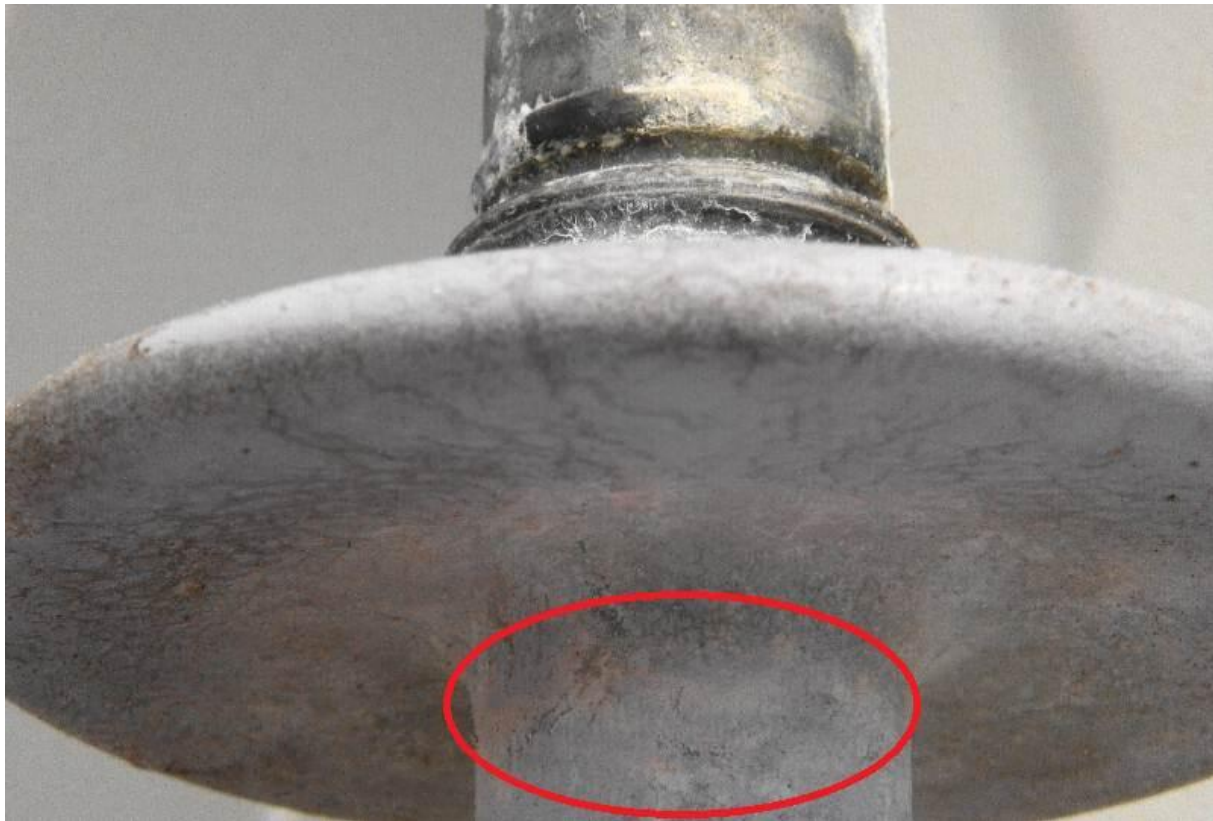
Figure 5-33: Colour change observation on the DC+_RTV insulator

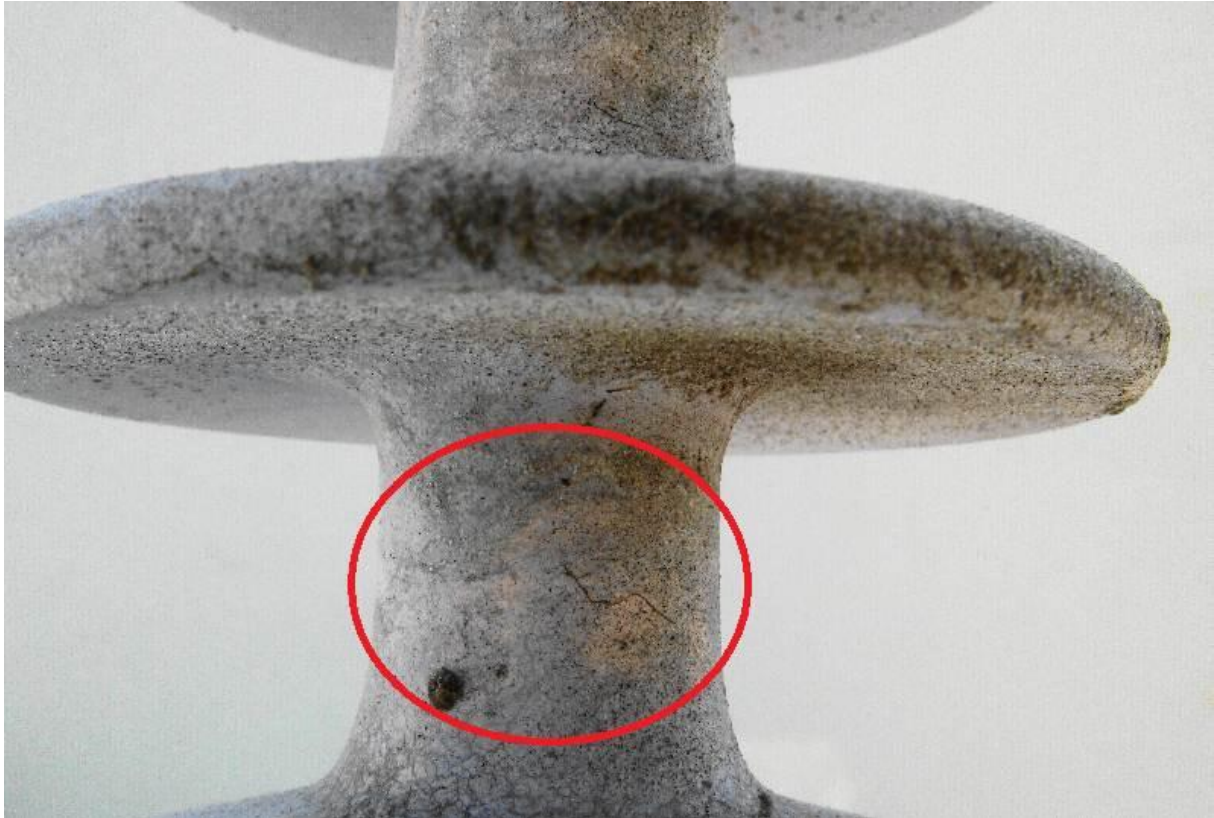
Figure 5-34: Colour change observation on the DC-_RTV insulator

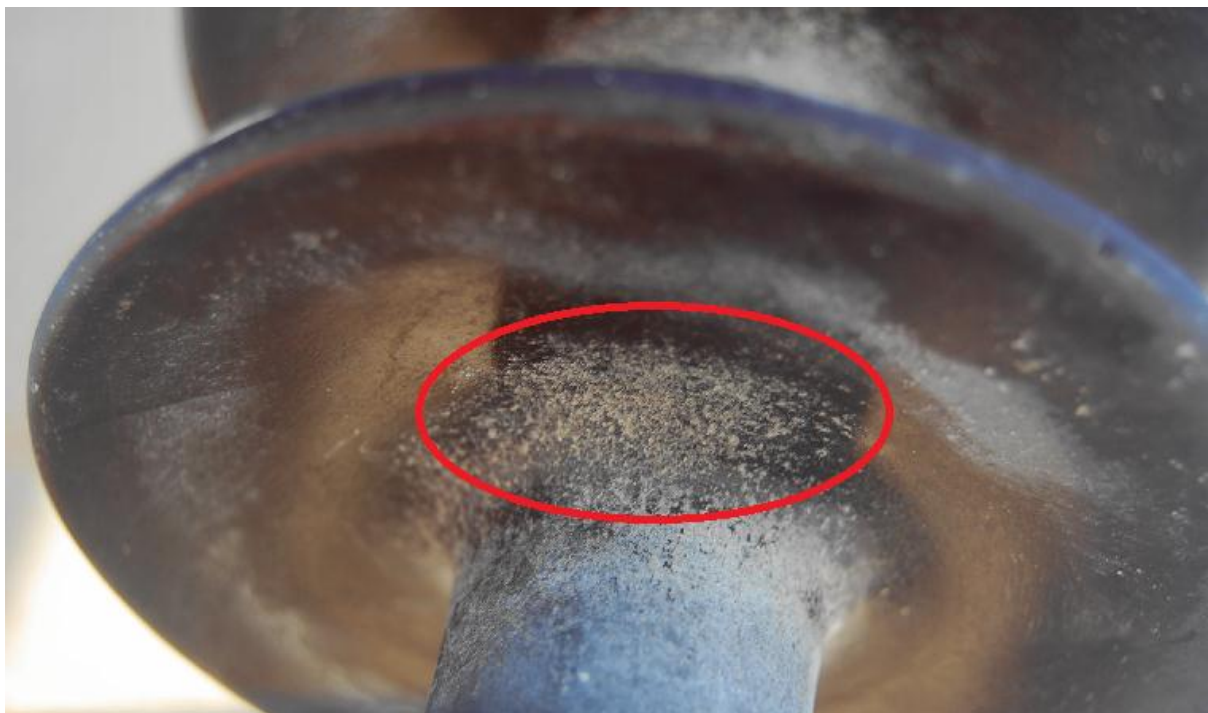
Figure 5-35: Chipped glazing observation on the DC+_Porcelain insulator
